Stardom Scientific Journal of Natural and Engineering Sciences

1st issue- 4th Volume 2026

Investigative Insights into Construction Materials of Oraby Tabia, Egypt: Addressing Durability Challenges through Multidimensional Analysis

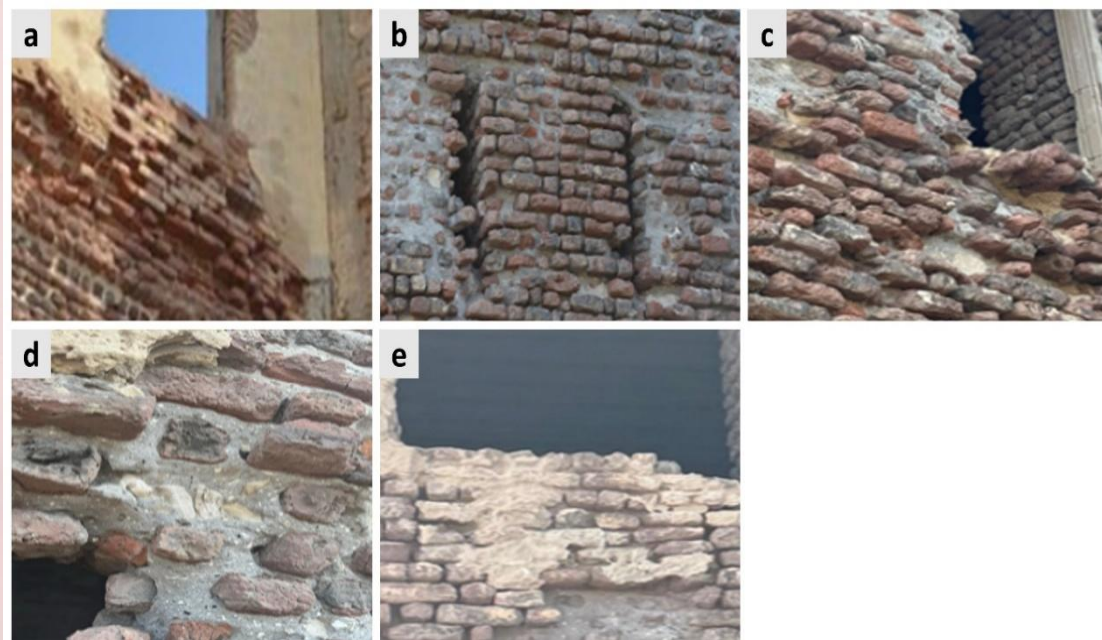
Fig. 6. Figure s for brick sites of a) first, b) second, c) third, d) fourth, and e) fifth sites, respectively.

The mechanical properties of the bricks were determined for samples collected from different sites in TO, as illustrated in Fig.6, to illustrate the difference in mechanical properties as the variation in site, and therefore the weather conditions, affects the durability of the tested bricks.

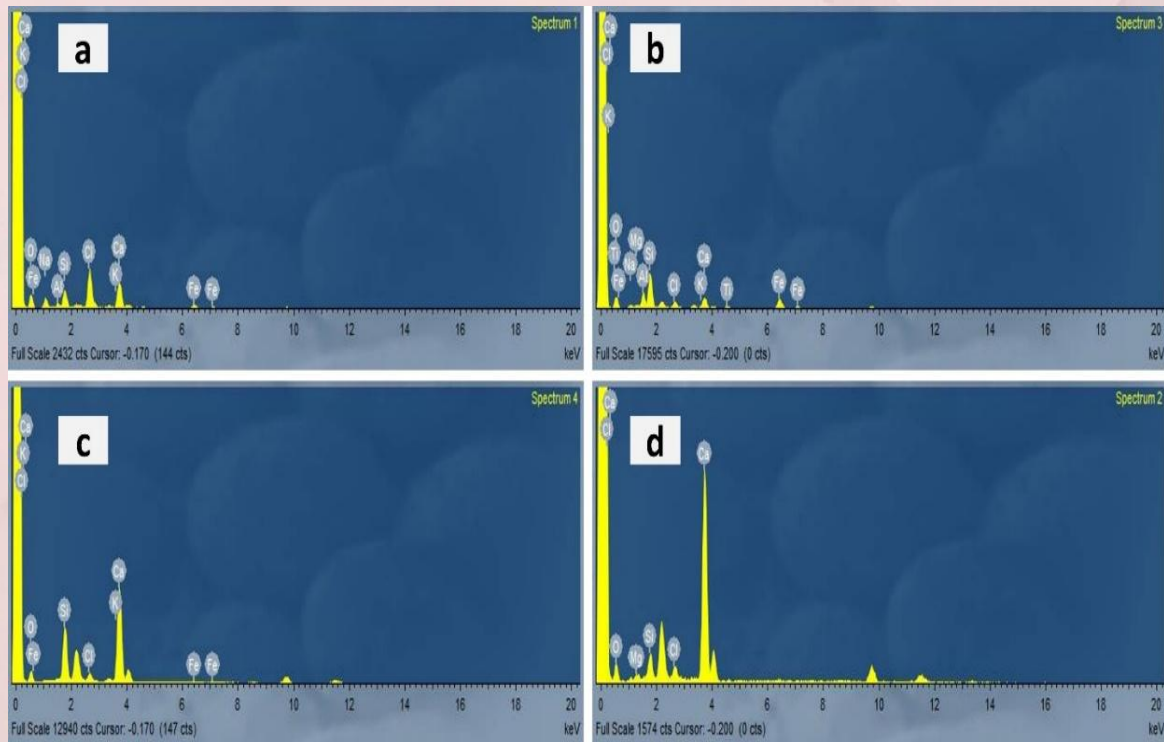
Fig. 8. EDX analyses the tested samples' surfaces of a) wood, b) bricks, c) mortar, and d) rocks.

EDX analysis provides useful screening information; confirmatory phase and ion analyses are recommended before conservation interventions. In this respect, EDX analysis of wood surfaces showed low-energy C and O peaks corresponding to lignocellulosic substrates [46]. These peaks of various exogenous minerals are superimposed on them, showing sodium, magnesium, aluminum, silicon, sulfur, chlorine, potassium, calcium, and trace iron or titanium [47]. Based on EDX analysis, the minerals may not have been part of the wood but were deposited on it. The Na and Cl both point to sodium chloride, which may be halite from sea sprays or aerosols. At the same time, the magnesium with Cl and S suggests magnesian salts like magnesium chloride or magnesium sulfate [48]. In addition, the peaks of Si, Al, and K show siliceous dust or silicate clays or feldspars. The calcium in the presence of sulfur indicates fine calcite or gypsum, picked mortar. Therefore, the surfaces of wood need to be cleaned well before the potential conservation process.

Fig. 8 (b) shows the EDX analysis of bricks, which illustrates that high Si and Al levels are characteristic of silicates (in this case, clay) and form the framework mineralogy of the bulk alumino silicate of the bricks. Furthermore, the high content of Fe may correspond to iron oxides present in the red and brown fired clays. In addition, the detectable Ca is due to lime source of bricks, and mortar attached to the brick's surface. Moreover, the common trace minerals of the natural clays, such as Ti, Mg, and K, were observed in EDX analysis of the tested brick samples. Na and Cl peaks may indicate the presence of salts on the surface of bricks as a result of weather conditions.

Regarding mortar samples, they showed a strong presence of Ca, suggesting mortar based mostly on lime (Portland/lime/secondary calcite) with surface cross-cement based on the limiter functional for historical mortars used. The co-existence of Si and Al in the mortar suggests there is sand (silica and aluminosilicates) added. Cl and Na on the surface of the mortar suggest contamination from soluble salts (marine aerosols).

Additionally, the large peak in calcium, along with modest silicon content and presence of oxygen, relates most closely to a limestone or calcite-rich stone. The presence of silicon, aluminum, and magnesium in very low concentrations is characteristic of accessory silicate minerals or sand inclusions. The chloride and sodium ions also indicate salt deposition on the surface of the rock, like bricks and mortar.

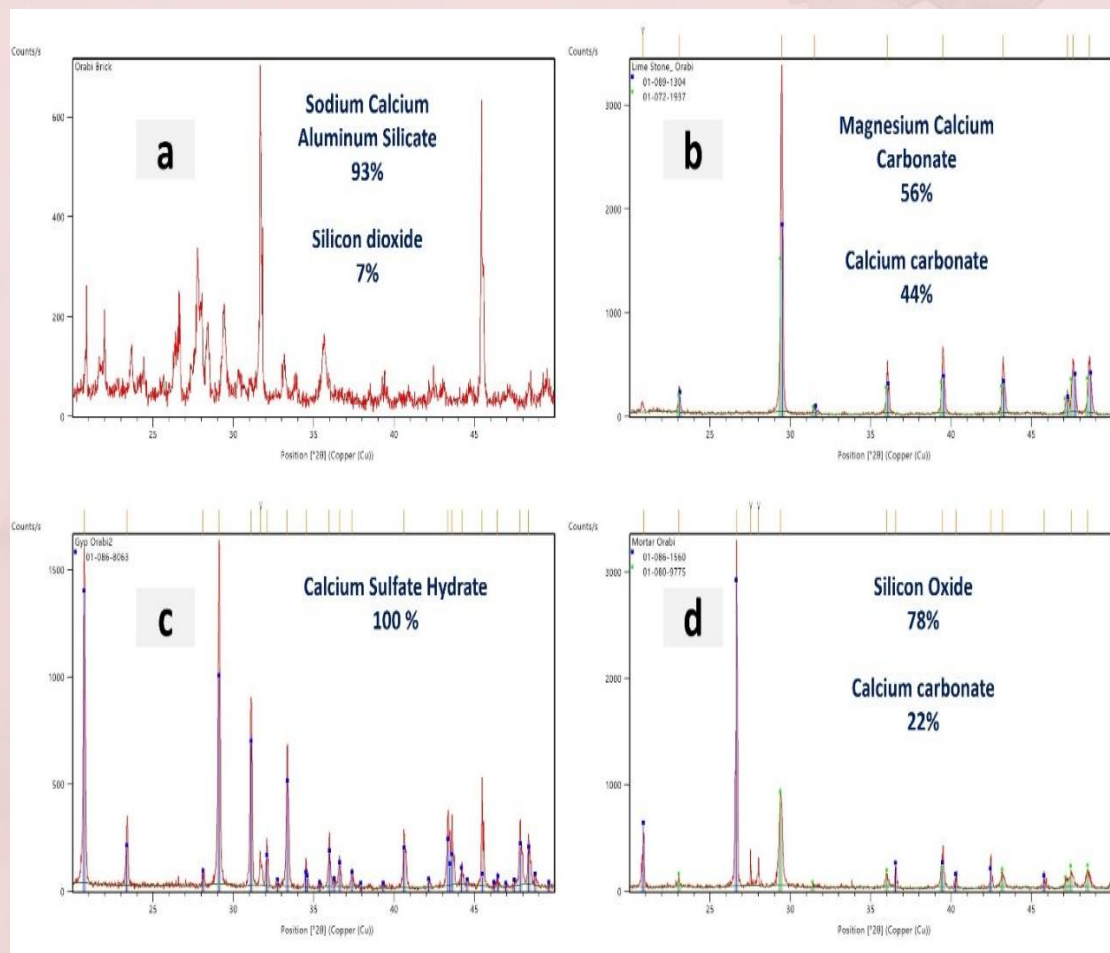
Fig. 9. XRD patterns of a) bricks, b) rocks, c) internal mortar, and d) external mortar

The XRD pattern of the brick sample shows that the phases of sodium calcium aluminum silicate are the most prominent, although there are small amounts of silicon dioxide. This type of mineralogy is known for fired clay ceramics rich in feldspathic and silicate phases, which is indicative of brick making in Egypt. Even small amounts of crystalline silica indicate that the raw material was quartz sediment rich. While these phases aid in the brick's mechanical strength and overall durability, an excess of quartz can cause microcracking due to thermal expansion mismatches during firing.

The internal mortar sample is entirely composed of calcium sulfate hydrate (gypsum). This finding confirms the use of gypsum plaster as a binding material, a practice historically documented in Egypt due to the abundance of natural gypsum deposits. Gypsum mortars offer advantages such as rapid setting and good adhesion; however, they are highly soluble and vulnerable to moisture infiltration, which can cause volumetric changes, powdering, and eventual loss of cohesion. On the other hand, the external mortar displays a dominance of silicon oxide (quartz) and a notable fraction of calcium carbonate. This mixture implies the use of sandy aggregates bound with a lime-based matrix. Such lime-silica mortars are characteristic of traditional construction techniques, offering enhanced durability, breathability, and resistance to weathering compared to gypsum-based mortars.

The tested samples indicated an intentional separation of construction materials depending on their functional purposes. In order to achieve structural strength, bricks were made of silicate-rich compositions, while local carbonate rocks served as structural blocks. There were different types of mortar; gypsum mortars were used solely for internal applications, while external applications for silicate-lime mortars were to increase weathering resistance. This arrangement confirms Egyptian knowledge of advanced materials for construction and the ability to provide balance among availability, function, and robustness of building materials [49-50].
